HEFFRON PARK SWIMMING CENTRE, MAROUBRA NSW

**JEREMY MOFFAT
INDUSTRIAL GALVANIZERS**

Introduction

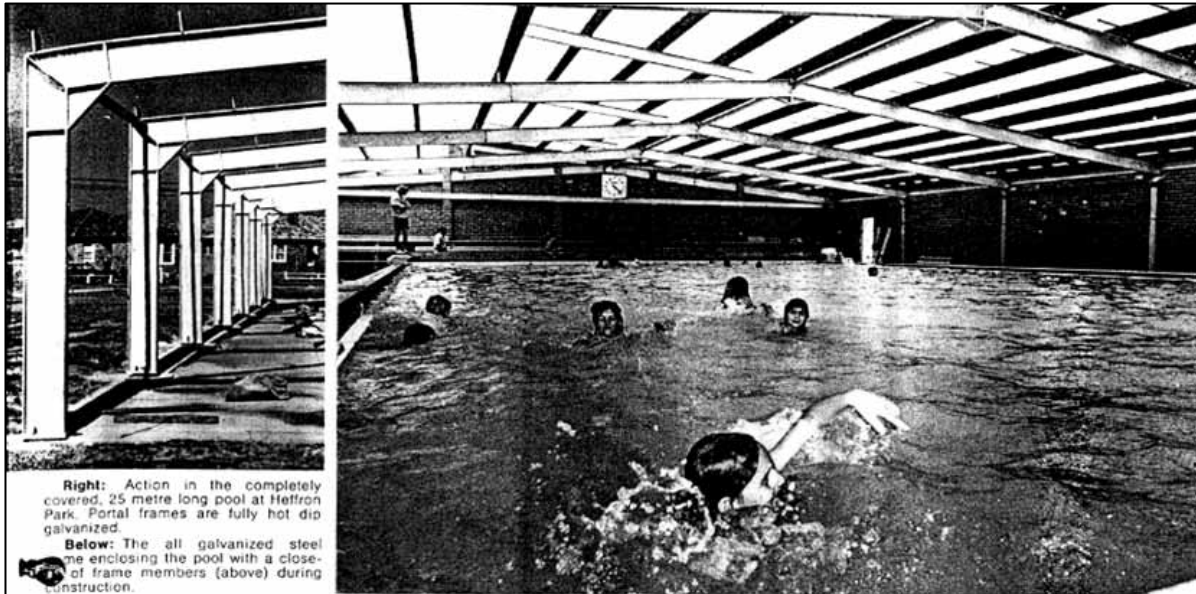
Right: Action in the completely covered, 25 metre long pool at Heffron Park. Portal frames are fully hot dip galvanized.

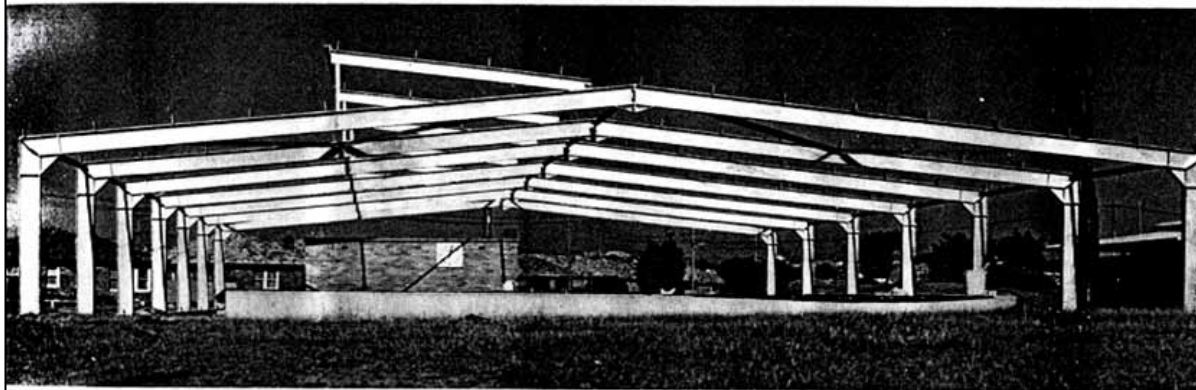
Below: The all galvanized steel frame enclosing the pool with a close-up of frame members (above) during construction.

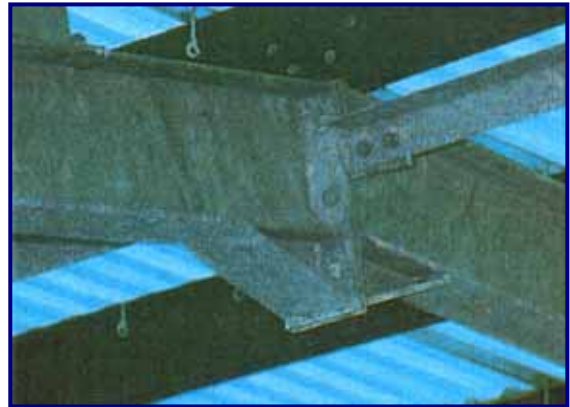
1990

Comments: The 25 metre pool was built in 1971 and enclosed in a 33m x 18.5m x 3.8m high structure in 1975. The seven portal frames which support the building were all hot dip galvanized and the coating is still in good condition, measuring 100-120 μm , despite the humid chlorine environment.
