**Performance Report of Hot Dip Galvanized Coatings**  
**at**  
**Consolidated Rutile Limited**  
**Stradbroke Island Separation Plant**

**30 February 1998**

**Prepared by:**            **Russell Sheehan**  
                                 **Industrial Galvanizers Corporation**

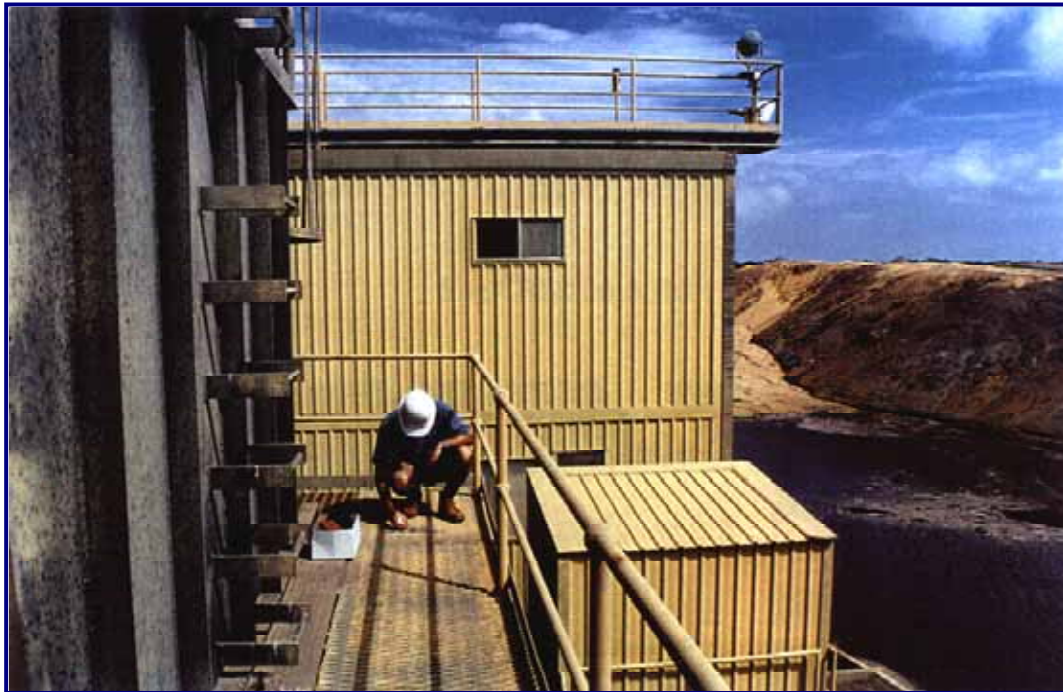
### Site CRL1

**Site CRL1:** Tromel Walkway – Discharge End (Southern). GR50110 Expanded Mesh Walkway. This walkway and platform were galvanized and installed in 1984. This steelwork has always been exposed to the salt spray wind typical of this coastal marine environment.

Original coating thickness requirement was  $84\mu\text{m}$  or  $600\text{ grams/m}^2$ .

102, 93, 76, 82, 101, 73, 82, 92, 129, 85

Ave:  $91.5\mu\text{m}$

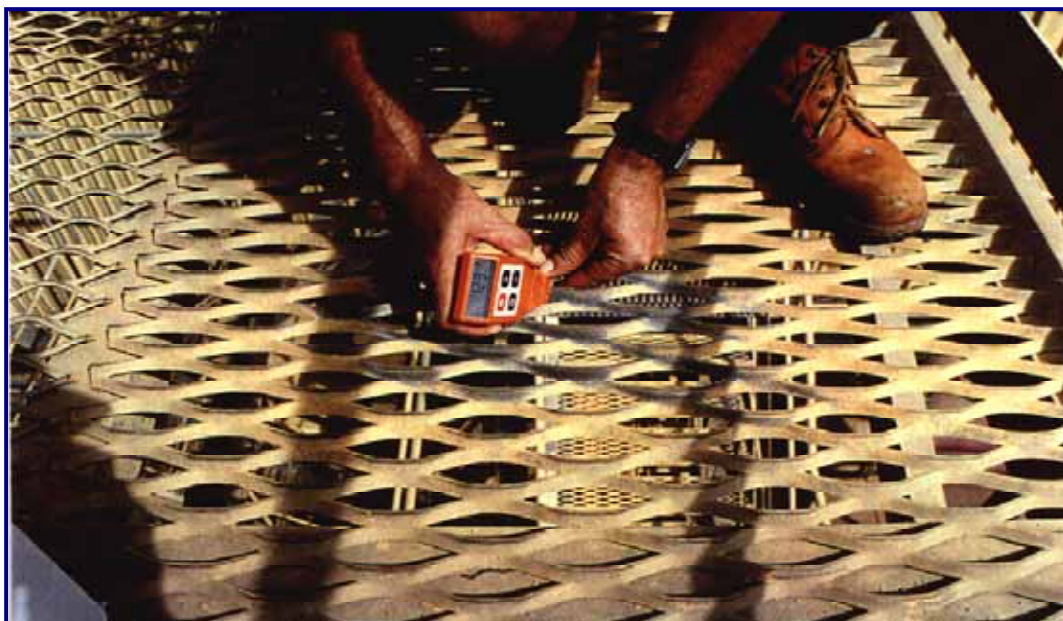
**NB. Average thickness reading remains higher than original requirement.**

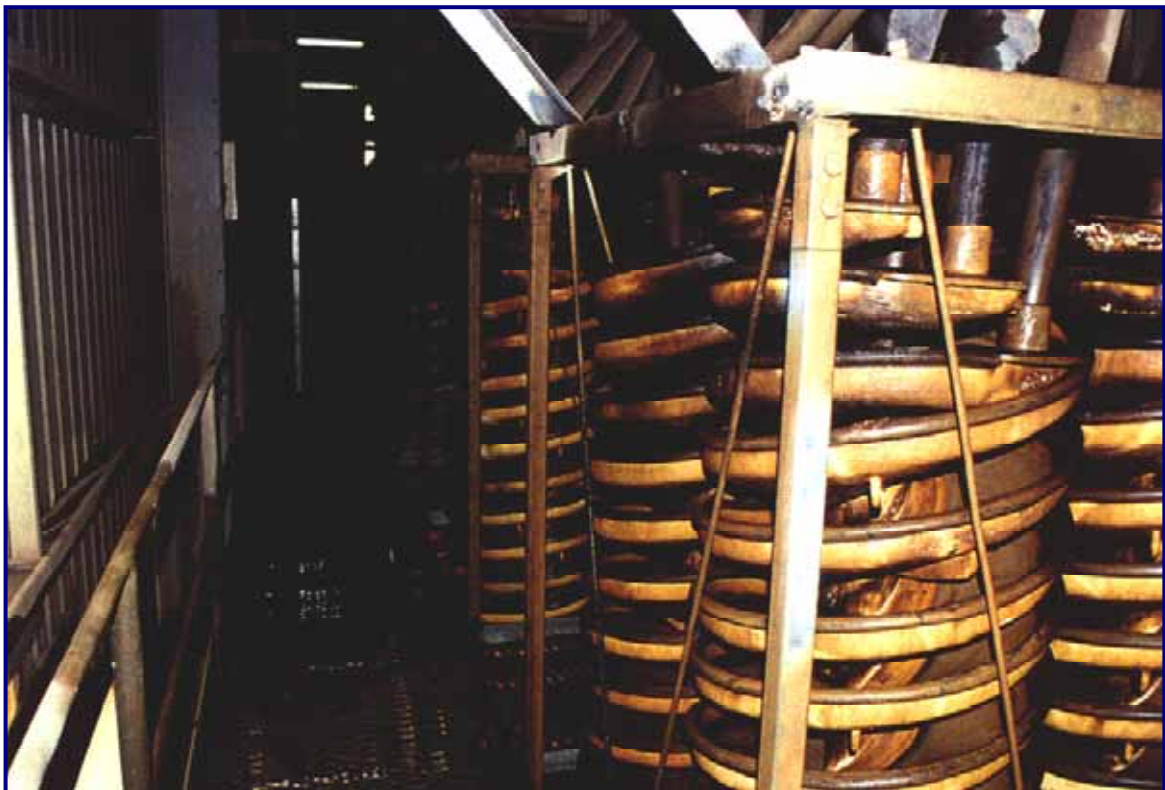
### Site CRL2 (a) & (b)

**Site CRL2 (a) & (b):** The Rougher Spiral Frames - Intermediate level. These are the support frames for the separation spirals, galvanized and installed in 1984. Test site (a) was on the 50mm x 50mm x 4.0mm Rectangular Hollow Section steel. Test site (b) was on the 100mm x 100mm x 10mm hot rolled steel angle.

Original thickness requirement for (a) was  $63\mu\text{m}$  or  $450\text{ grams/m}^2$ .  
Original thickness requirement for (b) was  $84\mu\text{m}$  or  $600\text{ grams/m}^2$ .

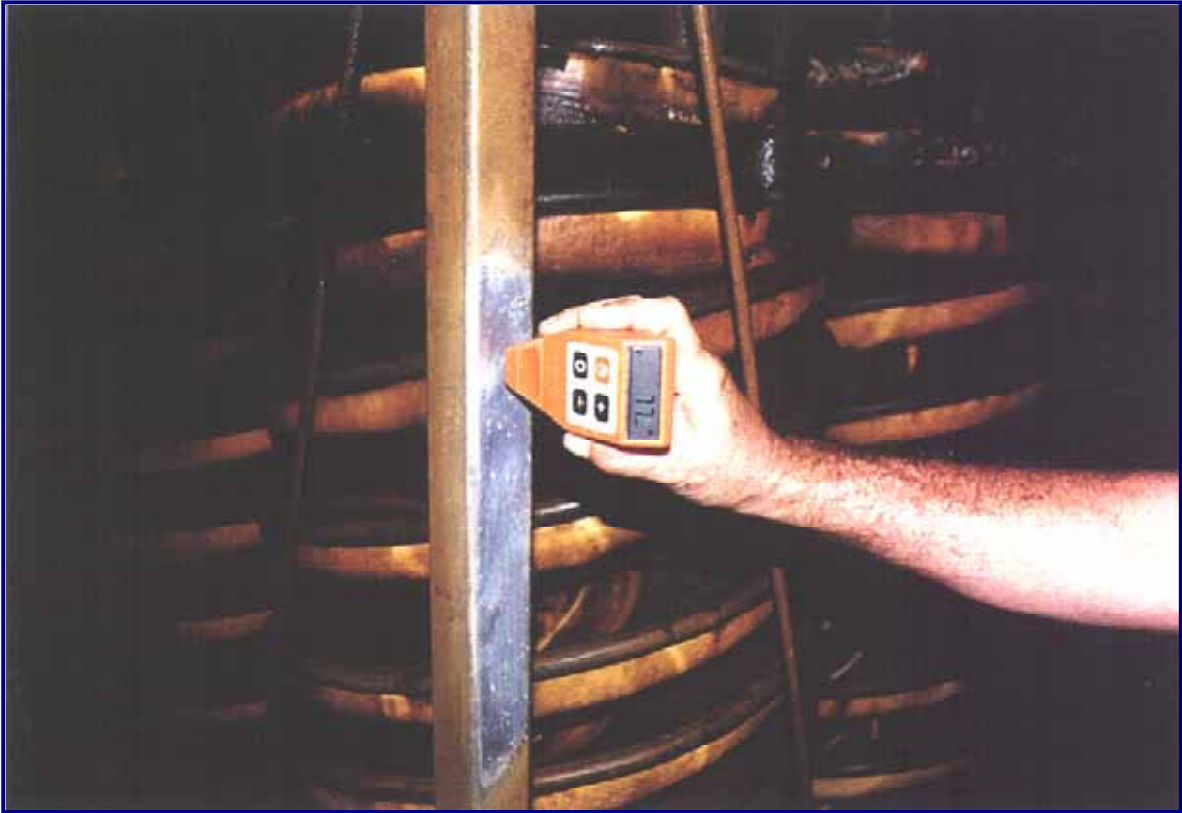
Ave:  $80.3\mu\text{m}$

**Site CRL2 (a) – 4.0mm thick RHS section coating thickness reading.**

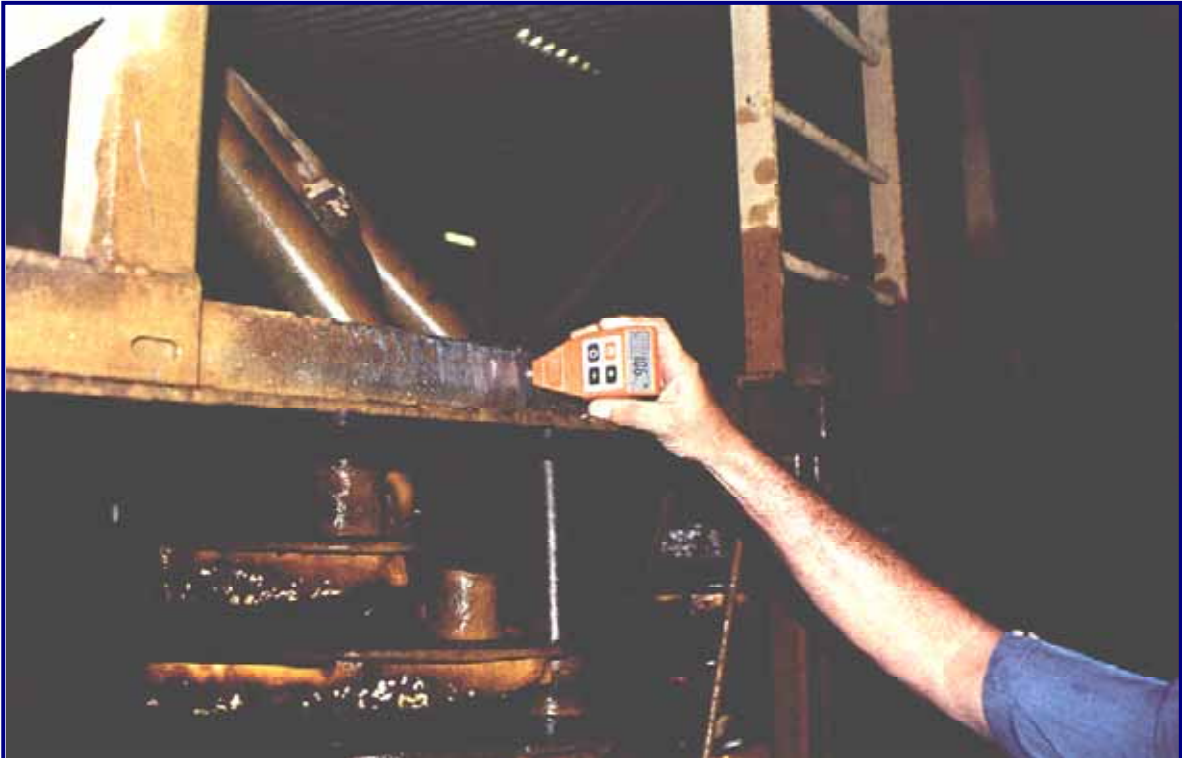
Ave:  $136\mu\text{m}$

**Site CRL2 (b) – 10mm thick ANGLE section coating thickness reading.**

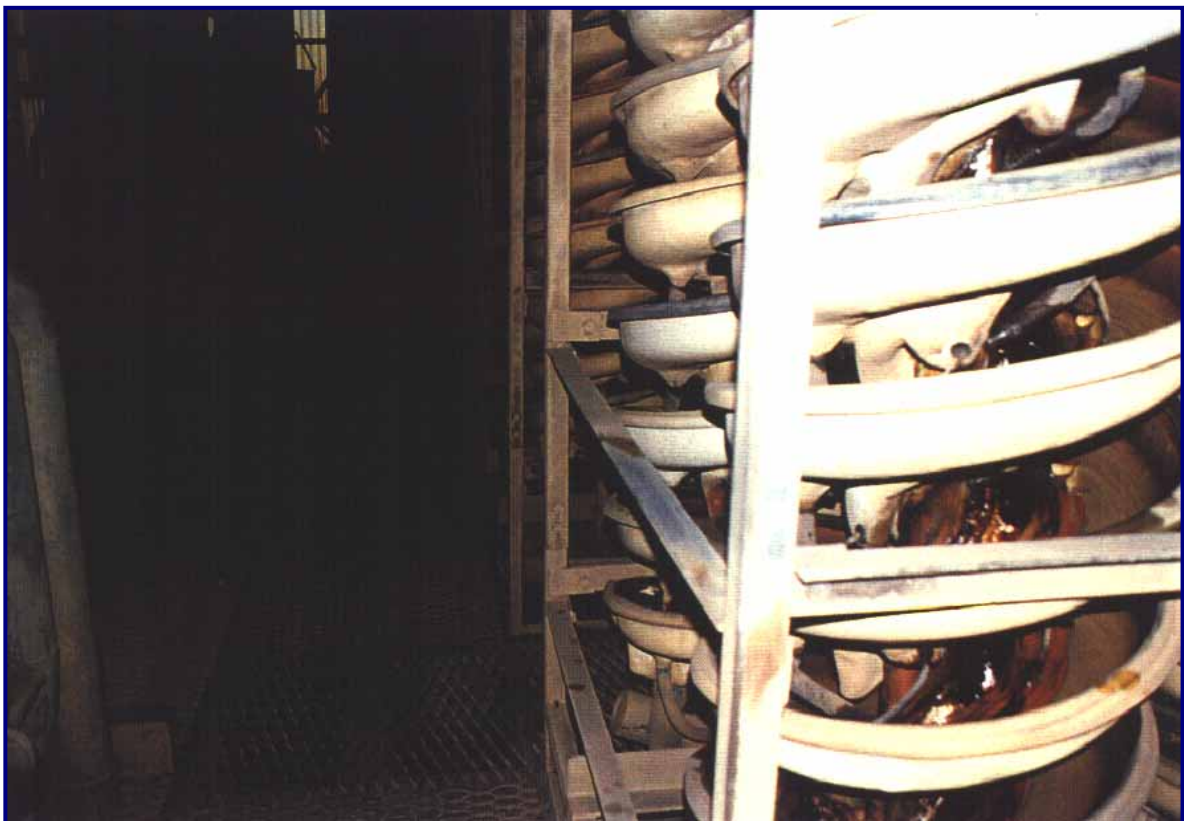
**Sites: CRL3 (a) & (b)**

**Site CRL3 (a) & (b):** The Cleaner Tailles Scav 1 Spiral Frames. These are the support frames for the separation spirals, galvanized and installed in 1984. Test site (a) was on the 50mm x 50mm x 4.0mm Rectangular Hollow Section steel, Test site (b) was on the 65mm x 65mm x 5mm hot rolled steel angle.

Original thickness requirement for (a) was  $63\mu\text{m}$  or  $450\text{ grams/m}^2$ .  
Original thickness requirement for (b) was  $84\mu\text{m}$  or  $600\text{ grams/m}^2$ .

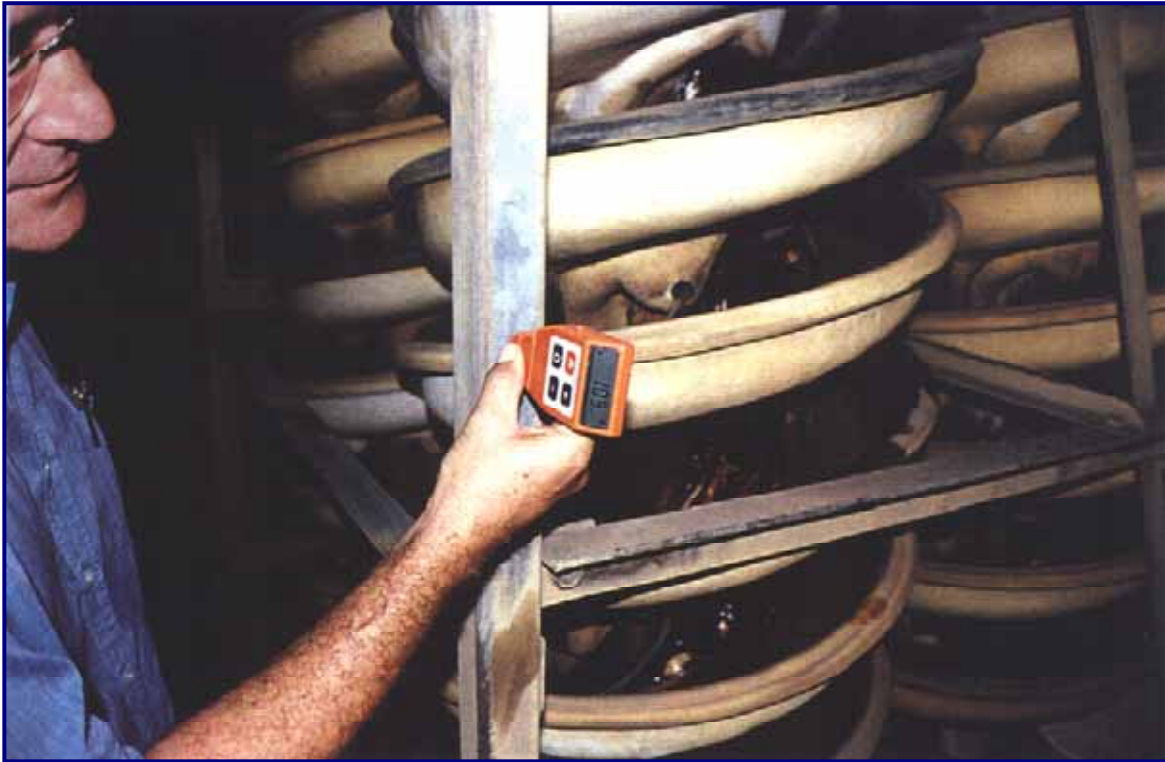
Ave:  $98.5\mu\text{m}$

**Site CRL3 (a) – 4.0mm thick RHS section coating thickness reading.**

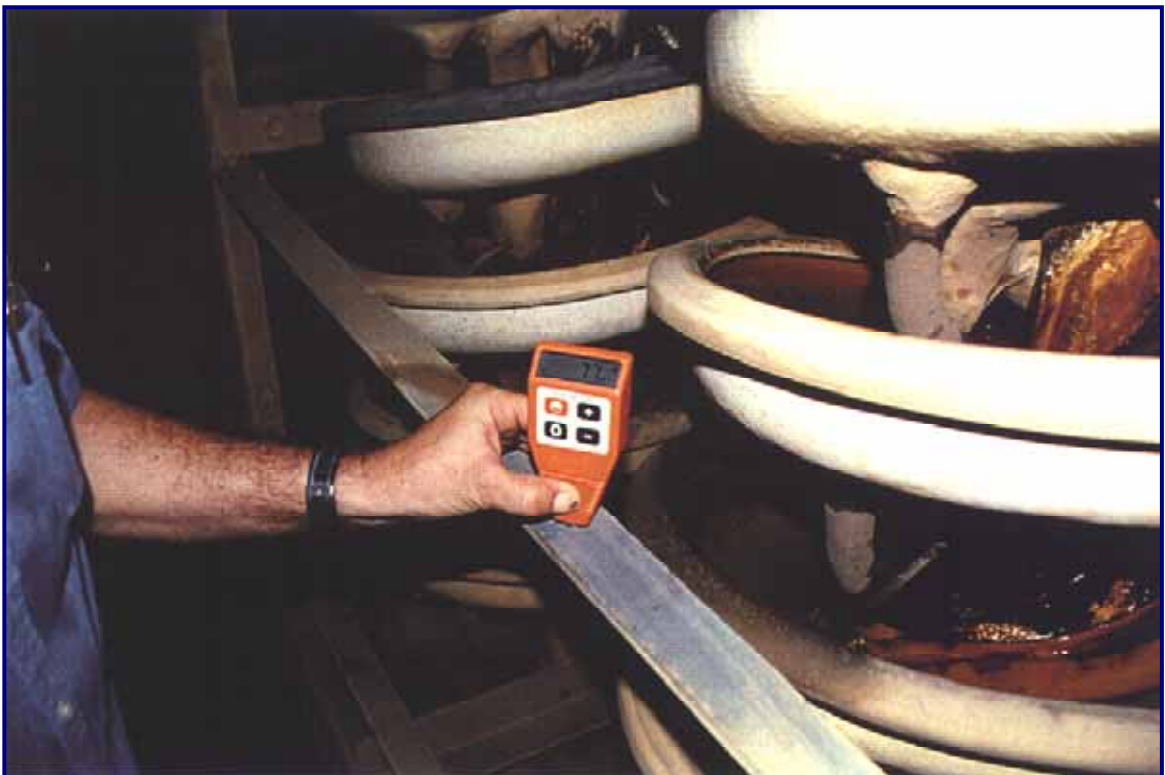
Ave:  $94.1\mu\text{m}$

**Site CRL3 (b) – 5mm thick ANGLE section coating thickness reading.**
