Performance Report of Hot Dip Galvanized Coatings
at
Consolidated Rutile Limited
Stradbroke Island Separation Plant

30 February 1998

Prepared by: **Russell Sheehan**
 Industrial Galvanizers Corporation

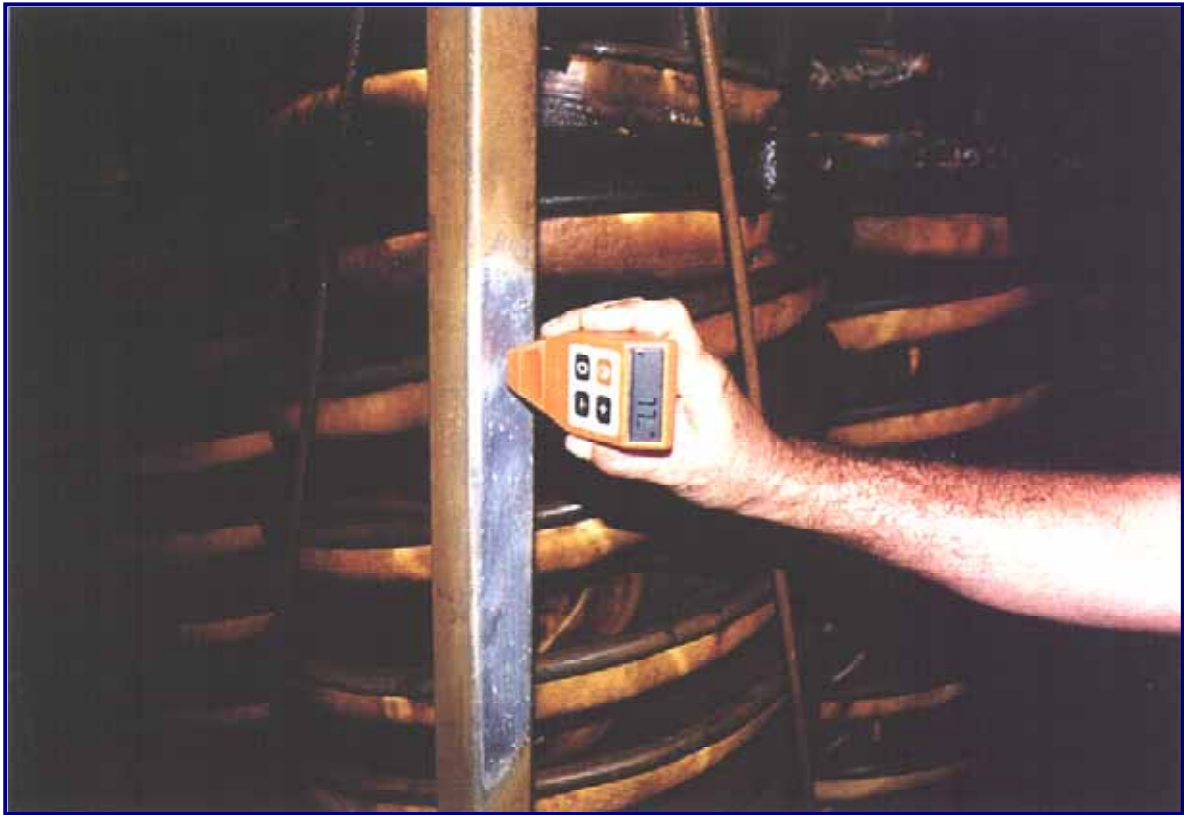
81, 82, 80, 85, 77, 80, 83, 74, 78, 83

Ave: $80.3\mu\text{m}$

Site CRL2 (a) – 4.0mm thick RHS section coating thickness reading.

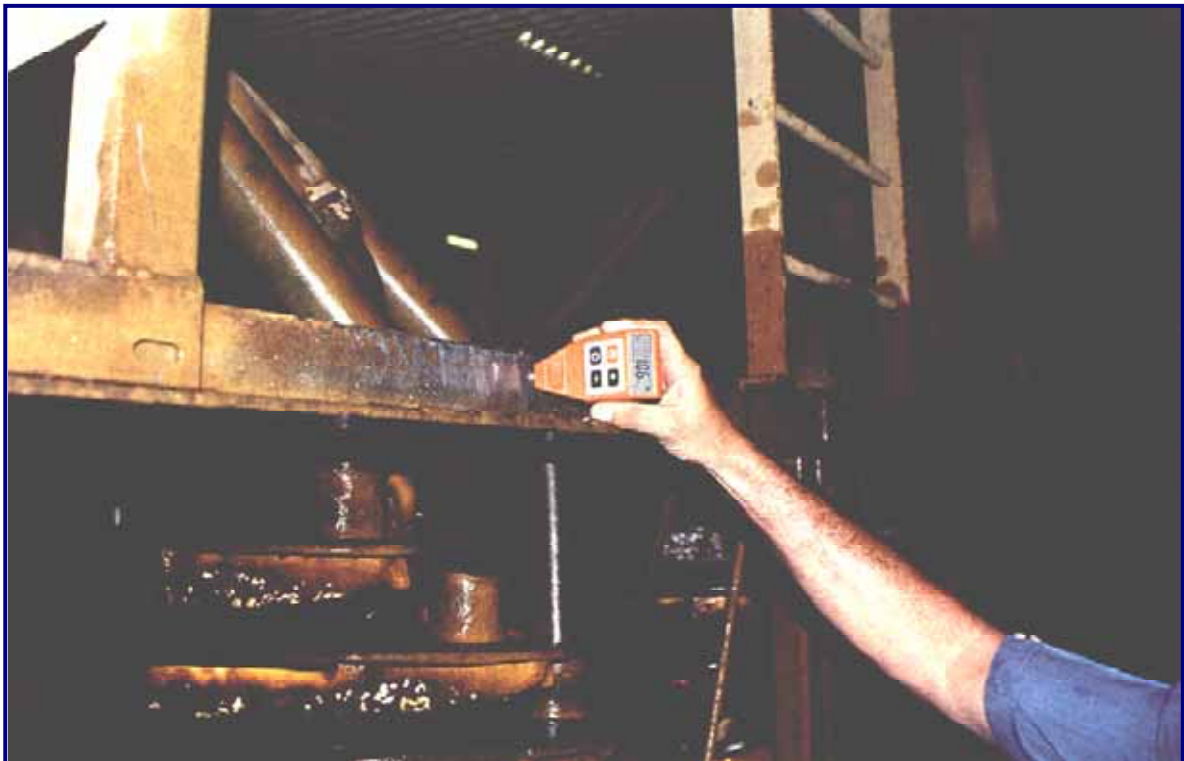
165, 166, 122, 137, 106, 152, 127, 130, 131, 124

Ave: $136\mu\text{m}$

Site CRL2 (b) – 10mm thick ANGLE section coating thickness reading.

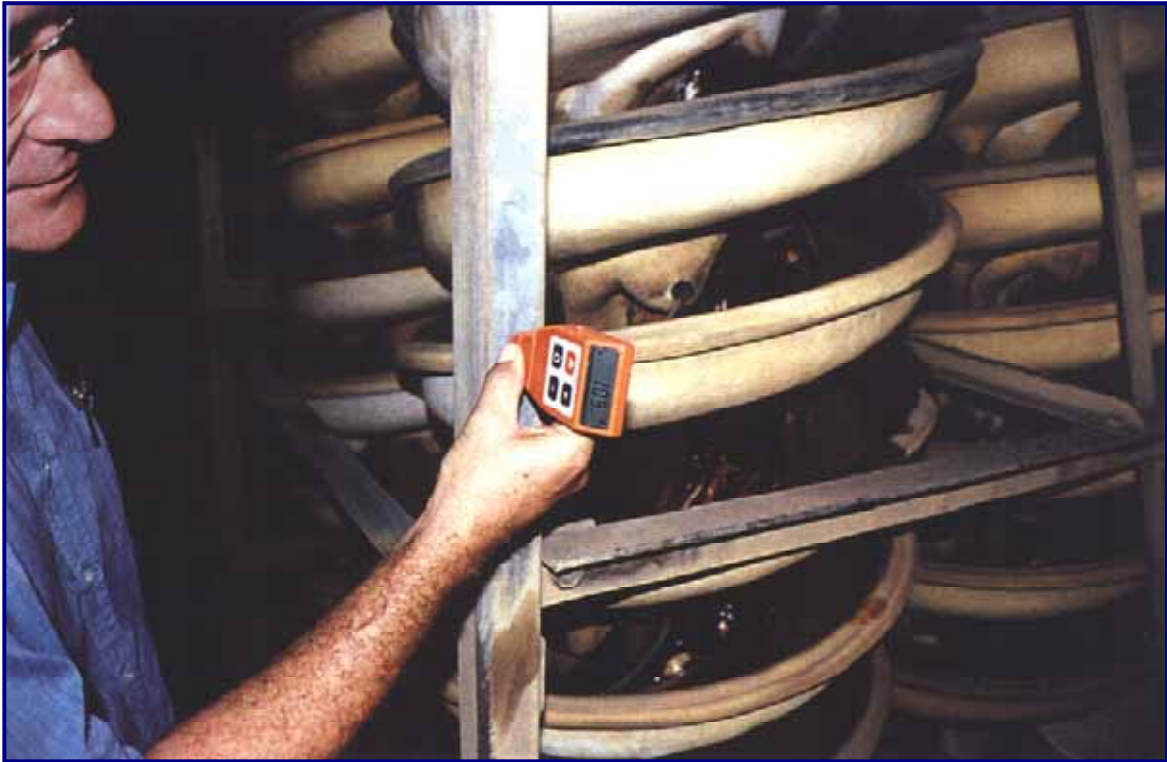
92, 105, 97, 93, 89, 94, 111, 109, 98, 97

Ave: $98.5\mu\text{m}$

Site CRL3 (a) – 4.0mm thick RHS section coating thickness reading.

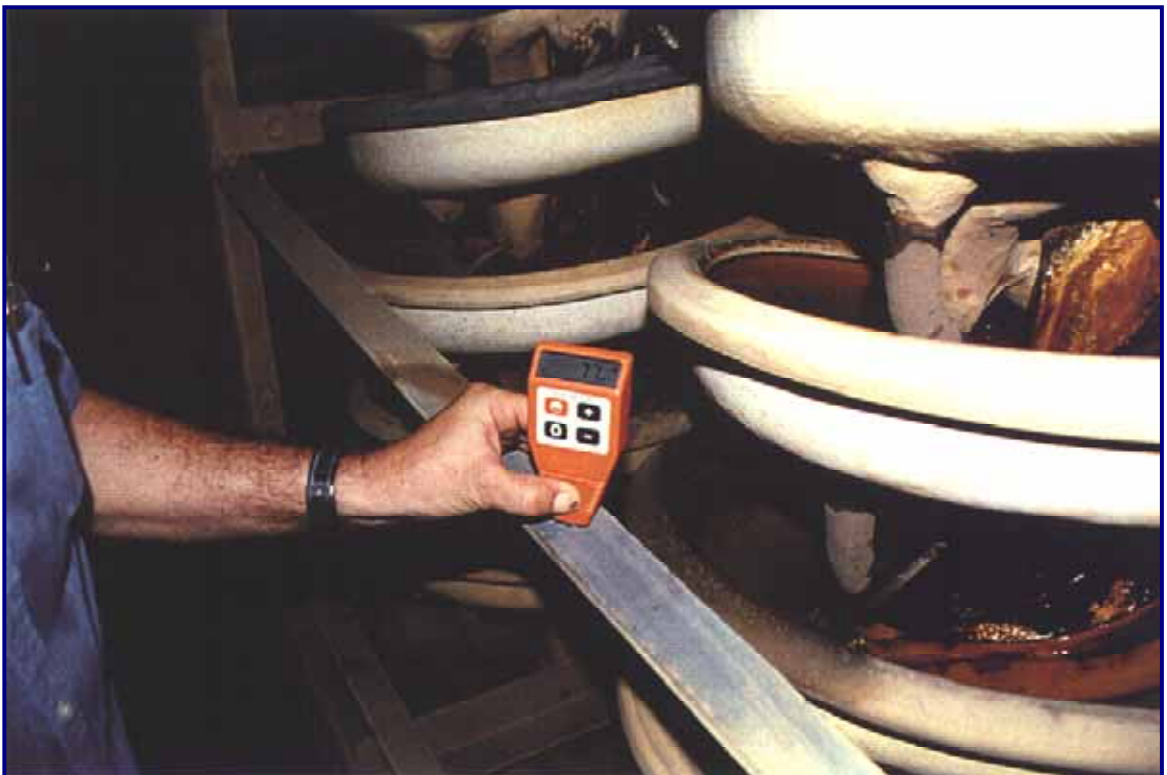
99, 77, 96, 92, 88, 111, 102, 88, 102, 86

Ave: $94.1\mu\text{m}$

Site CRL3 (b) – 5mm thick ANGLE section coating thickness reading.
