Performance Report of Hot Dip Galvanized Coatings

Surfers Paradise Ocean Front

24 February 1999

**CONDUCTED BY: SEAN McCORMICK
INDUSTRIAL GALVANIZERS**

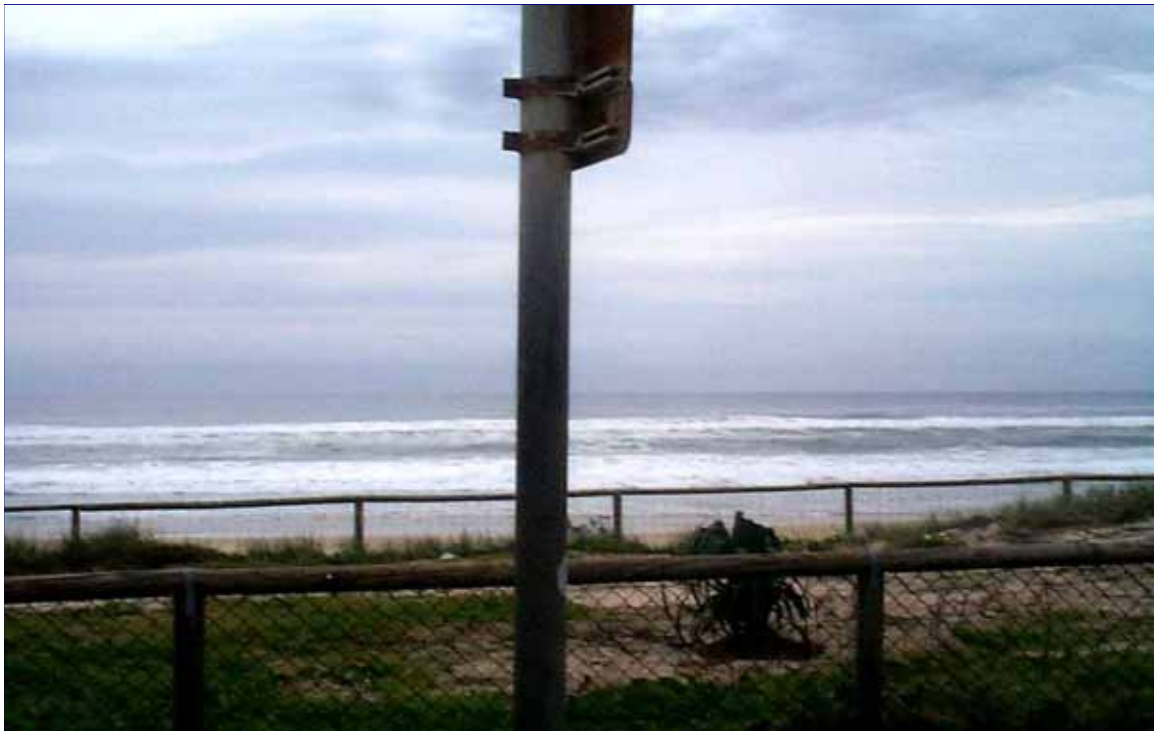
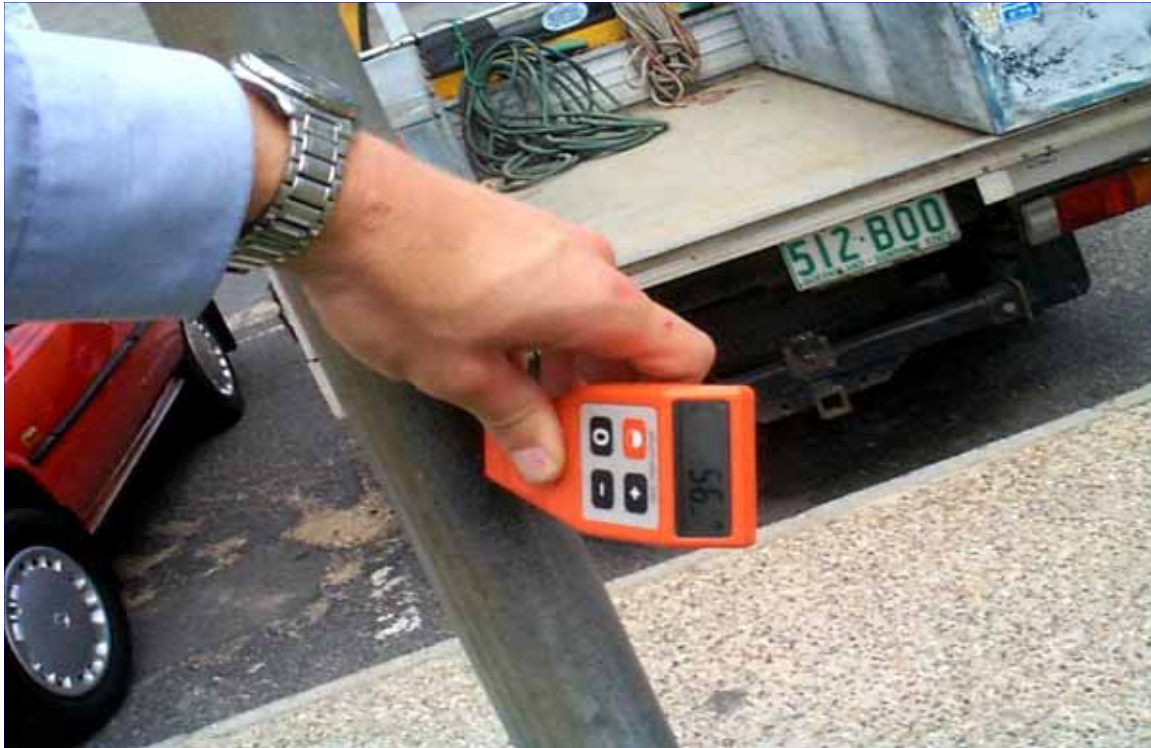
2.2.1 Site One: 75NB (3mm) Pipe Geoffery Cornish Walkway

This particular pole is at the very northern end of the walkway and is approximately 100 metres south of Wharf Road. The pole was galvanized and erected approximately six – seven years ago. Original coating thickness requirement was $63\mu m$ or 450 grams/m^2 .

53, 56, 52, 54, 58, 58, 49, 51, 43, 49

Ave: $52.3\mu m$

The 75NB pipe has an average reading today of $52.3\mu\text{m}$. Because of the way this pipe is galvanized it would be highly unlikely that its initial coating thickness would have been much greater than what the standard called for ($63\mu\text{m}$). However if you were to be extremely conservative and you said $100\mu\text{m}$ was the initial coating thickness, than you would achieve a corrosion rate of $8\mu\text{m}/\text{year}$ $((100-52)/6)$.

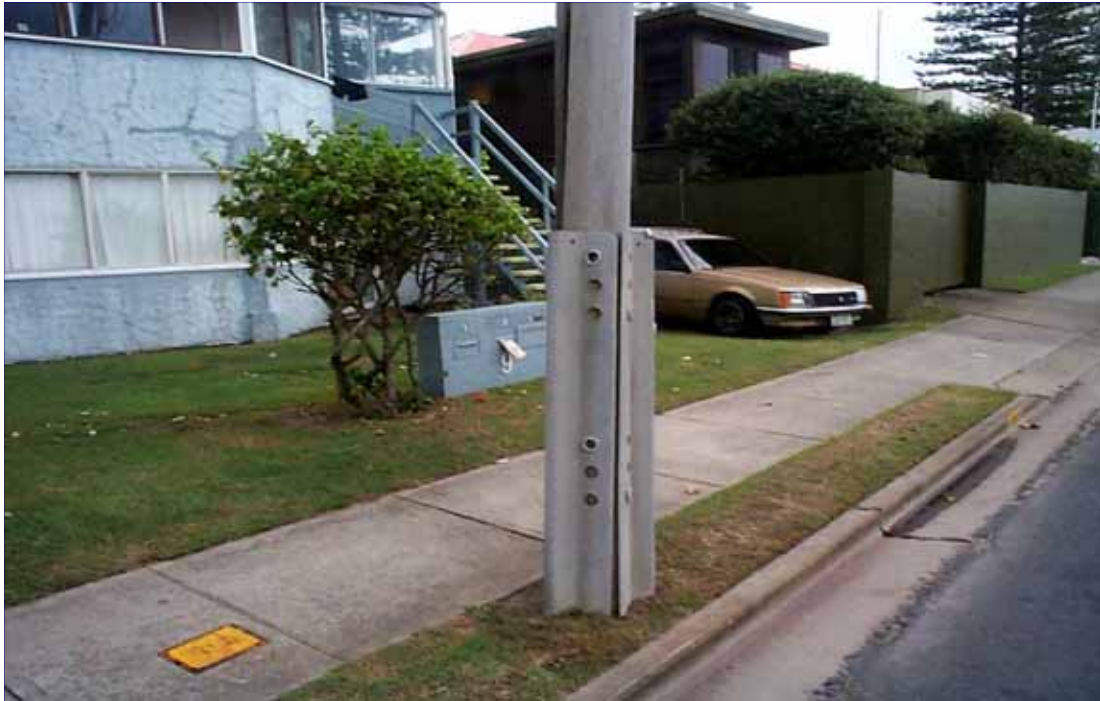
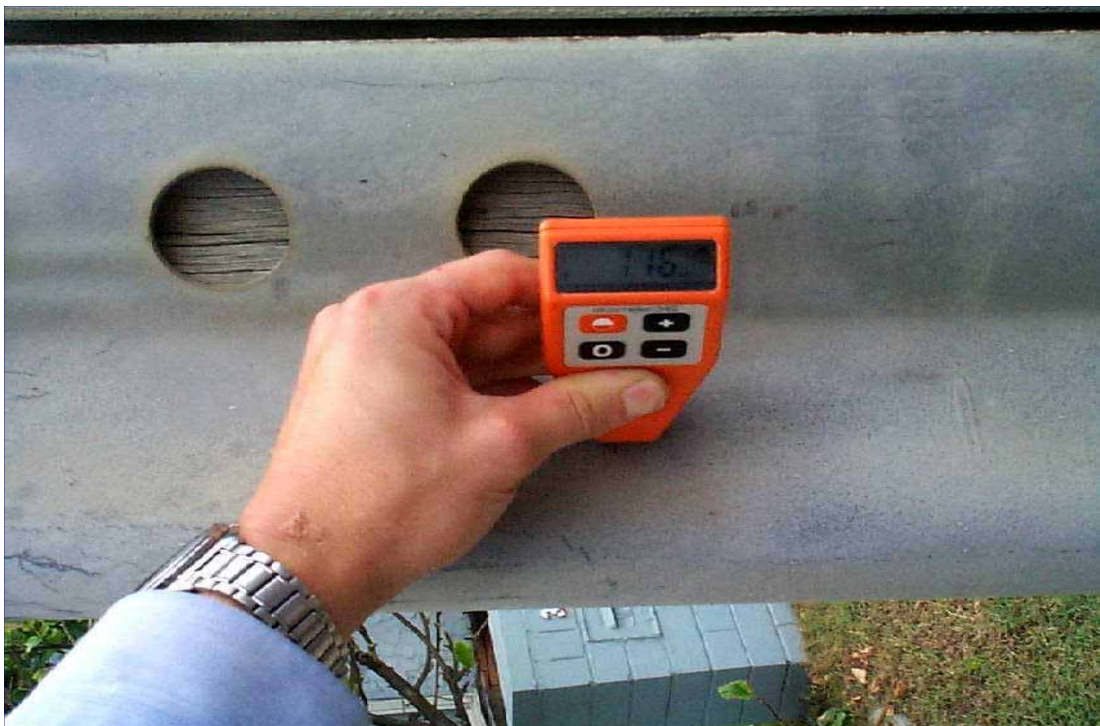
2.2.2 Site Two: Pole Nails (10mm FMS) Cnr Broadbeach Blvd & Second Ave

This pole nail is located approximately 150 metres south of Wharf Road. The pole nail was installed approximately 2.5 years ago in 1996. Original coating thickness requirement was $84\mu\text{m}$ or 600 grams/m^2 .

116, 108, 120, 104, 152, 104, 112, 103, 110, 118

Ave: $114.7\mu\text{m}$

Average readings on pole nails galvanized in our yard on the 24/02/99 averaged $130\mu\text{m}$. Therefore if we use $130\mu\text{m}$ as the original coating thickness on the pole nail tested at Surfers Paradise, you obtain a corrosion rate of $6\mu\text{m}/\text{year}$ $((130-115)/2.5)$.

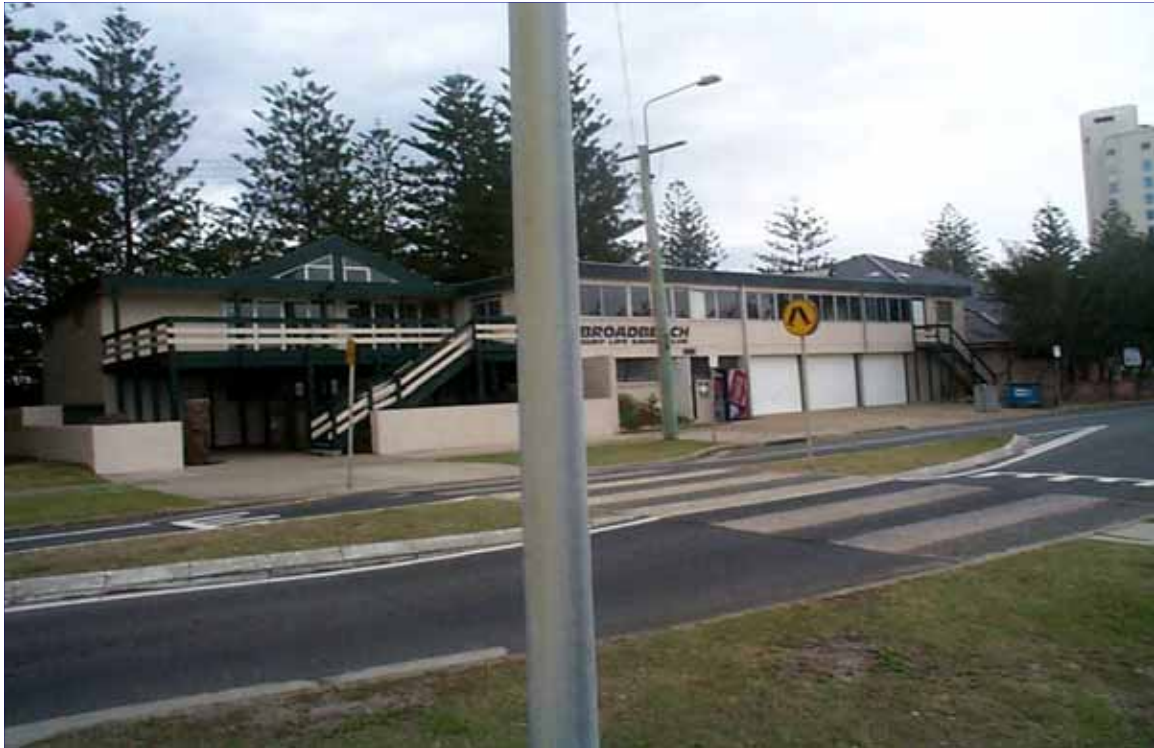
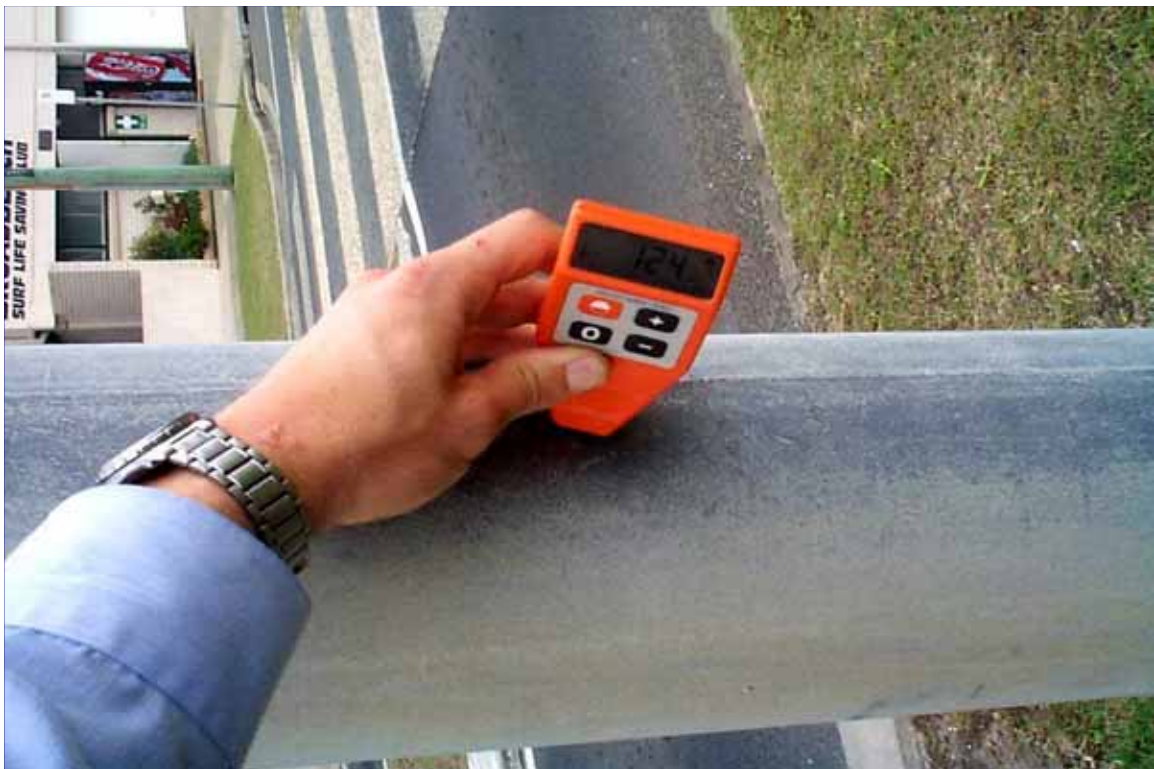
2.2.3 Site Three: Light Pole (5mm) Broadbeach Surf Life Saving Club

The readings on this light pole still remain well above the minimum requirements of AS1650, which is $84\mu\text{m}$ or 600 grams/m^2 . The pole is situated in front of the Broadbeach Surf Life Saving Club and was installed approximately 12 years ago.

124, 124, 129, 138, 123, 127, 112, 136, 126, 148

Ave: $128.7\mu\text{m}$

The average reading on the light pole tested at Surfers Paradise is well in excess of average readings on similar sections today. There are various reasons as to why the readings are so high, but if once again we err on the side of conservatism and say the initial coating thickness was $200\mu\text{m}$, we obtain a corrosion rate of approximately $6\mu\text{m}/\text{year}$ $((200-128.7)/12)$.
