**Performance of Hot Dip Galvanized Coatings**

**East Weipa Mine**

**- Dump Station -**

**CONDUCTED BY: INDUSTRIAL GALVANIZERS**

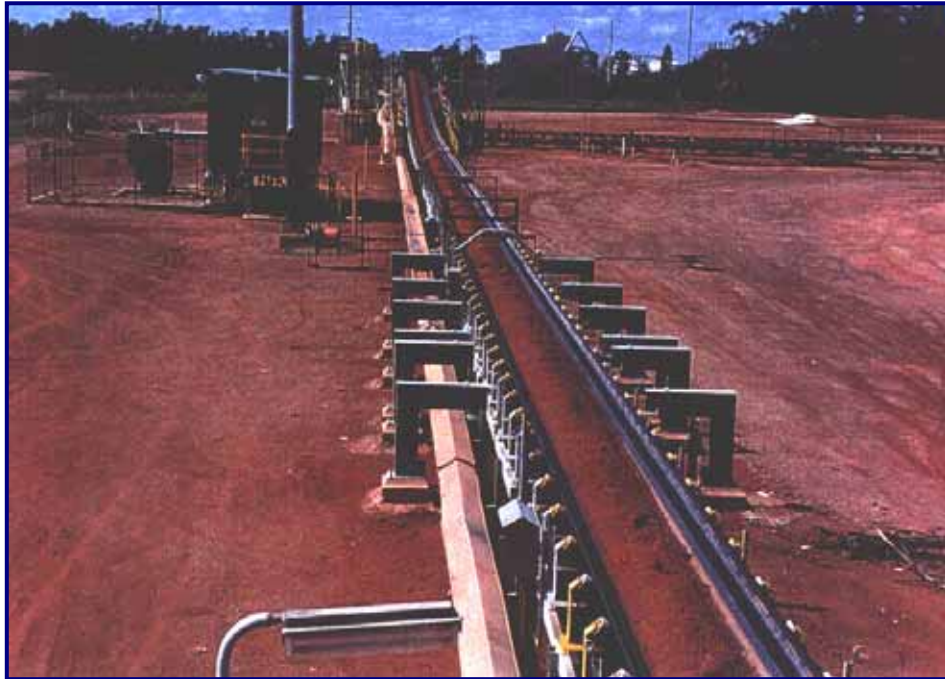
Weipa Dump Station Conveyors

Hot Dip Galvanized and Duplex Coated in some areas.

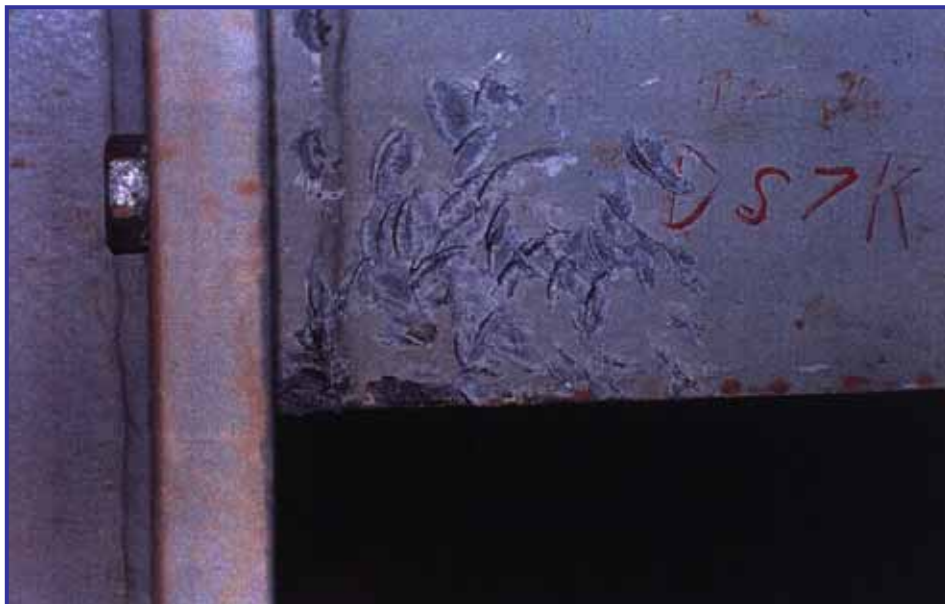
Duplex Coated steel damaged during breakdown repairs.

Note: HDG substrate still in tact protecting underlying steel from corrosion.

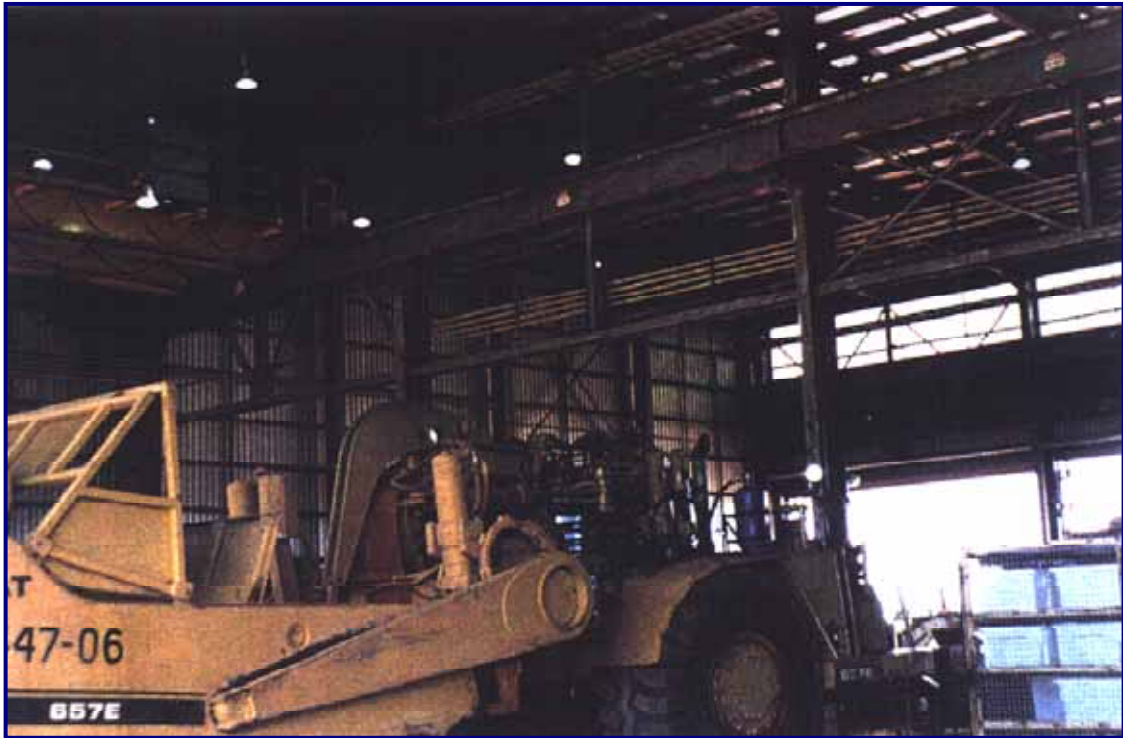
East Weipa Mine site – Heavy Vehicle Workshop

Erected in 1991

Coating thickness ranged from  $107\mu\text{m}$  to  $350\mu\text{m}$ ,

Well in excess of AS1650 requirement of  $84\mu\text{m}$ .

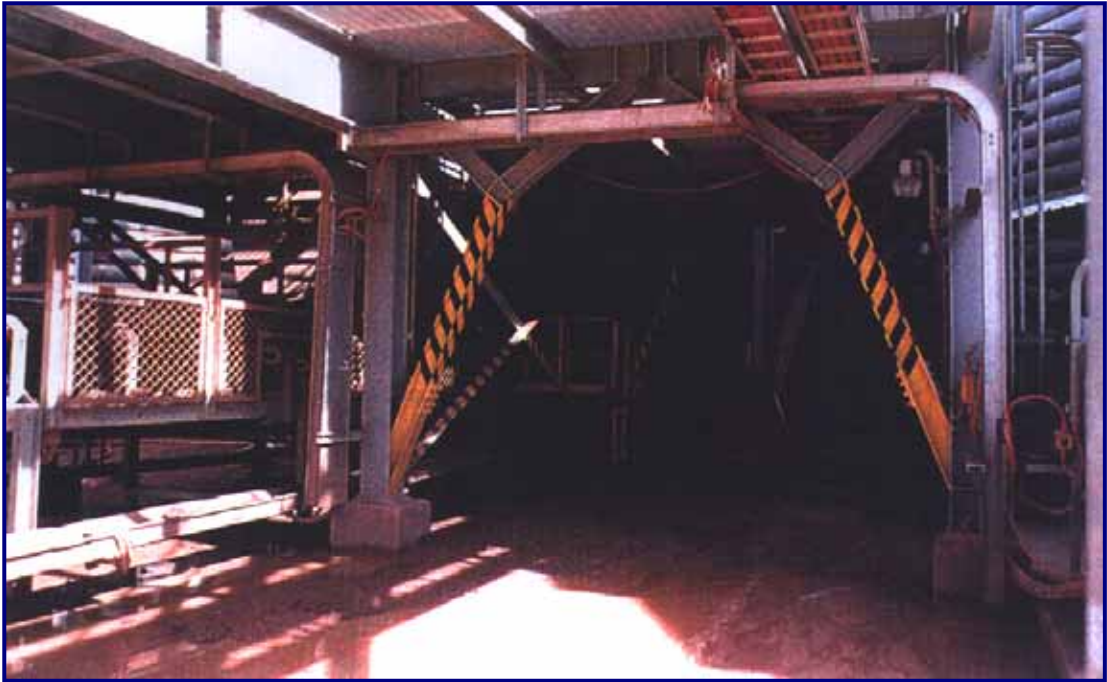
Weipa Dump Station

Duplex Coating – Hot Dip Galvanized with H.B. Epoxy top coat.

Coating thickness ranged from  $250\mu m$  to  $300\mu m$ .

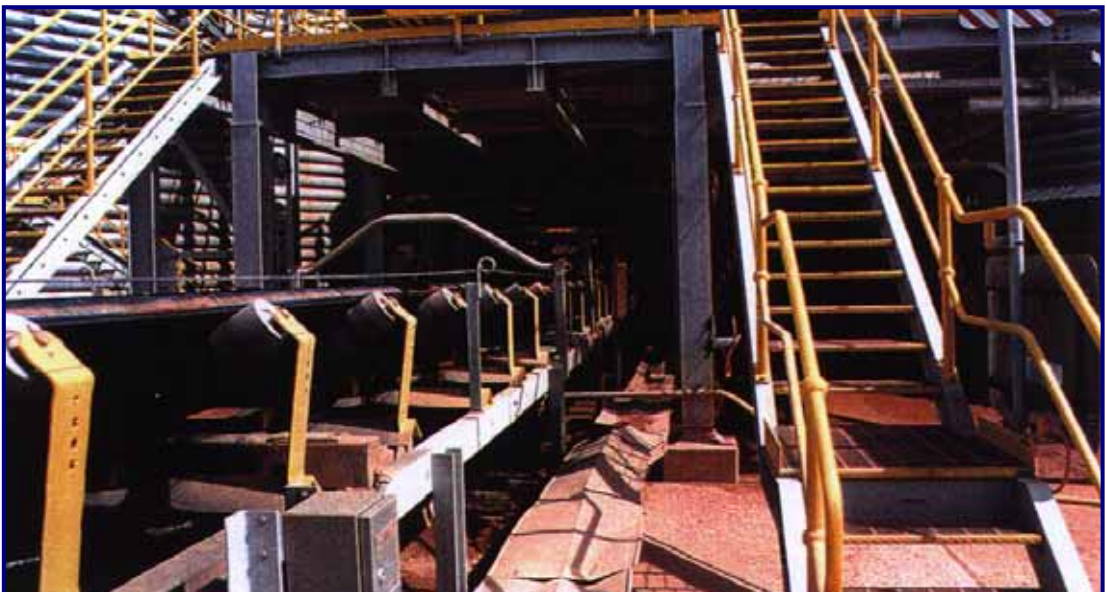
Weipa Dump Station

Hot Dip Galvanized columns and beams.

Coating thickness ranged from  $114\mu m$  to  $280\mu m$ .
