Performance Report
on
Interlok Grating

31 August 1999

CONDUCTED BY: SEAN McCORMICK
INDUSTRIAL GALVANIZERS

BRENT POLL
BHP BUILDING PRODUCTS

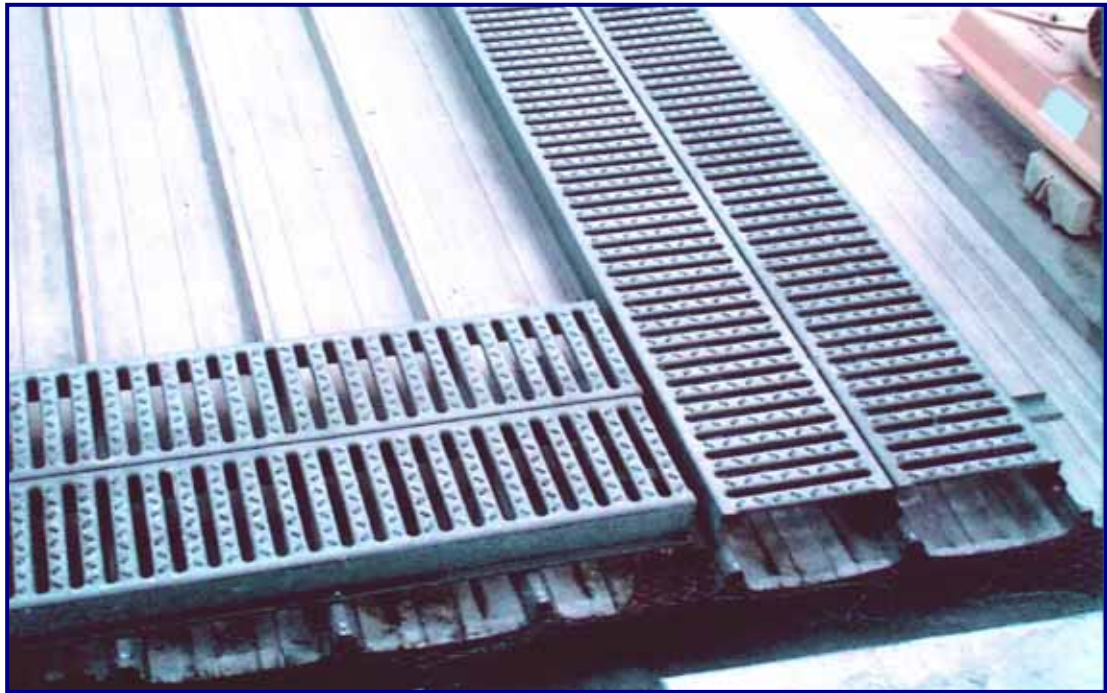
The shopping centre is located approximately two (2) kilometres from Deception Bay and it would therefore, at times, be susceptible to mild salt carrying winds. The Z450 Interlok[®] was installed in late 1993 to early 1994, making it more than five (5) years old.

Deception Bay Shopping Centre Roof

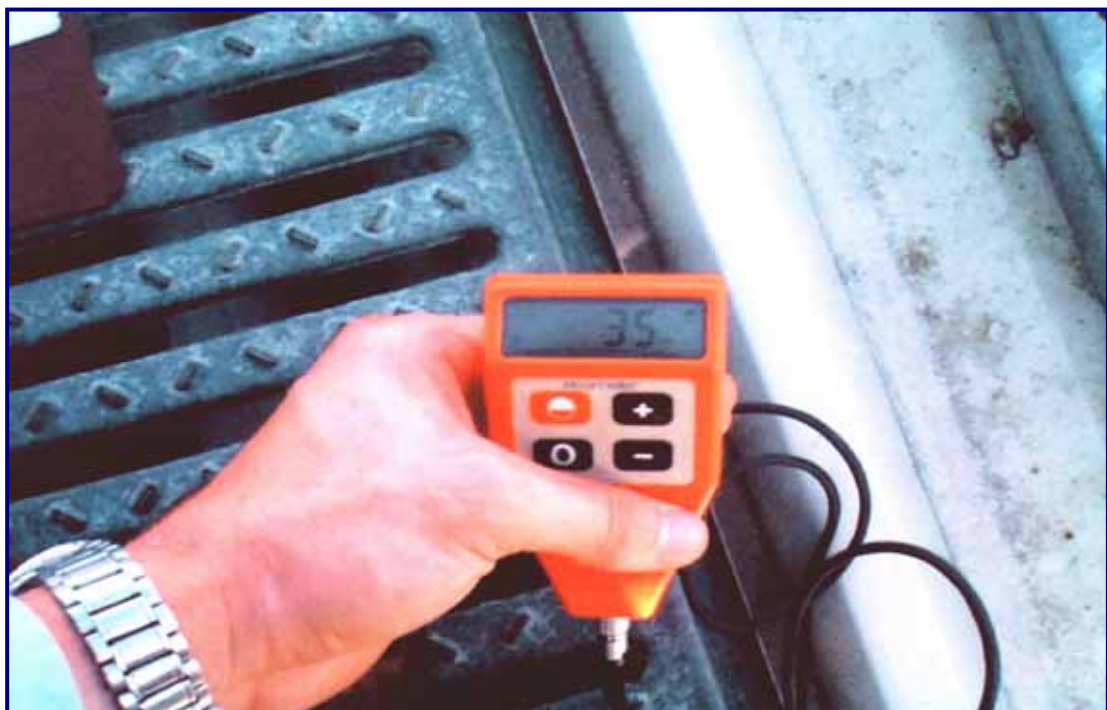
1.	Bottom Lip:	36, 32, 33, 33, 35, 25, 38, 37, 33, 39	Ave: $34.1\mu\text{m}$
	Side Flange:	32, 31, 31, 33, 39, 25, 25, 25, 36, 36	Ave: $31.3\mu\text{m}$
	Top Tread:	33, 34, 33, 33, 30, 30, 34, 30, 36, 36	Ave: $32.9\mu\text{m}$
2.	Bottom Lip:	36, 33, 34, 33, 36, 19, 39, 33, 27, 35	Ave: $32.5\mu\text{m}$
	Side Flange:	25, 32, 38, 31, 31, 24, 36, 30, 25, 30	Ave: $30.2\mu\text{m}$
	Top Tread:	35, 30, 30, 28, 29, 33, 31, 29, 33, 31	Ave: $30.9\mu\text{m}$

Deception Bay Shopping Centre – Bottom Lip Micron Thickness

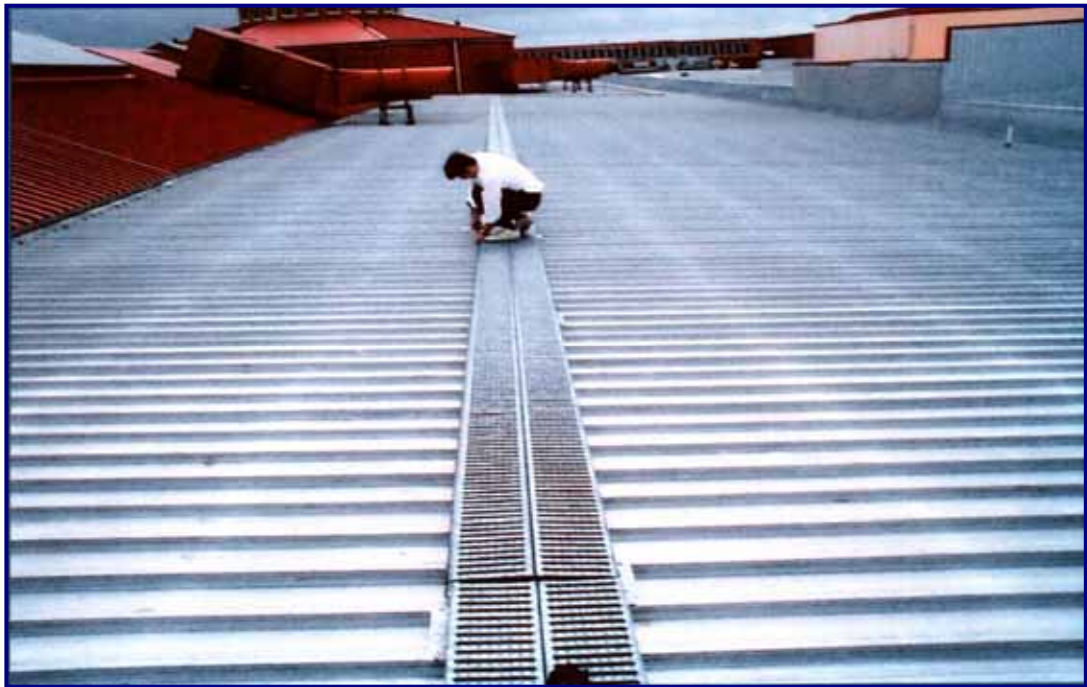
This roof provides a very interesting example, because it slopes from left to right (refer to the following photo). This type of design does not permit the water to flow out of the lipped channels on the grating, yet there is very little if an difference between the readings taken from the top tread and those on the bottom lip.

The reason for this is quite simple, Brisbane is a relatively dry and warm city. The Bureau of Meteorology reports that Brisbane's annual mean daily maximum temperature is 25.4°C and the annual mean daily evaporation is 5.3mm (commonwealth of Australia 1999). Combine this with the fact that the steel during some months will get well above 60°C it is highly likely that any water that happens to collect in the bottom lip will evaporate within one day.

Morayfield Shopping Centre – Roof Slopes from Let to Right

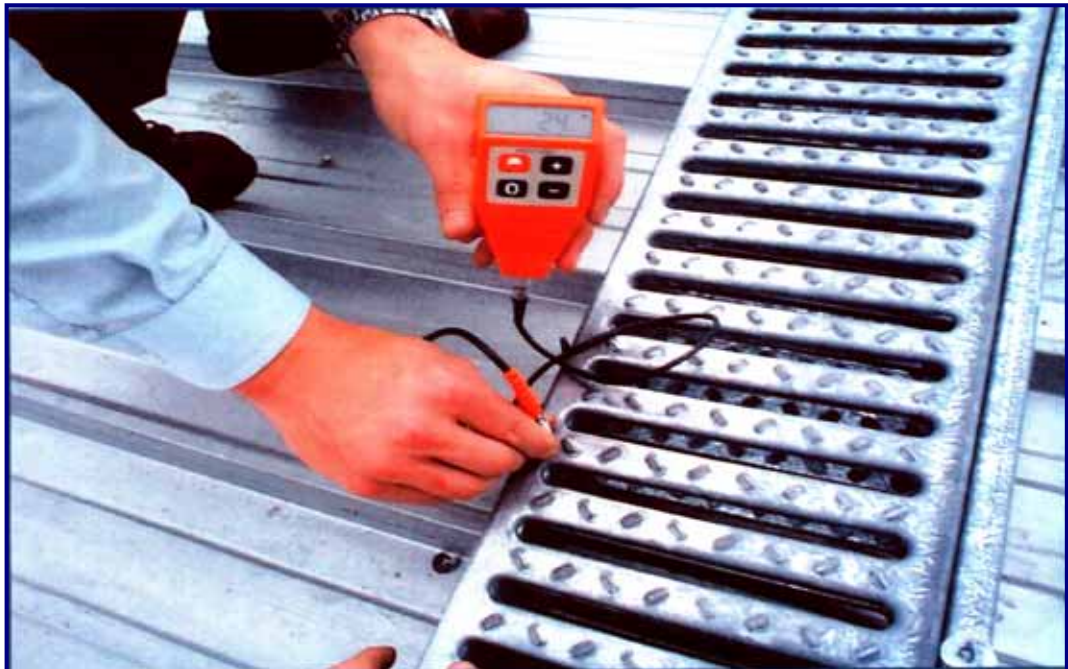
1.	Bottom Lip:	29, 31, 32, 31, 33, 23, 27, 28, 25, 24	Ave: $28.3\mu\text{m}$
	Side Flange:	34, 36, 33, 32, 28, 34, 32, 32, 23, 29	Ave: $28.1\mu\text{m}$
	Top Tread:	36, 29, 30, 39, 24, 33, 38, 31, 36, 25	Ave: $32.1\mu\text{m}$
2.	Bottom Lip:	34, 33, 22, 33, 33, 30, 39, 35, 31, 28	Ave: $31.8\mu\text{m}$
	Side Flange:	31, 29, 31, 34, 33, 30, 24, 30, 38, 28	Ave: $27.7\mu\text{m}$
	Top Tread:	28, 28, 23, 35, 39, 31, 30, 32, 28, 35	Ave: $30.9\mu\text{m}$

Morayfield Shopping Centre – Top Tread Micron Thickness

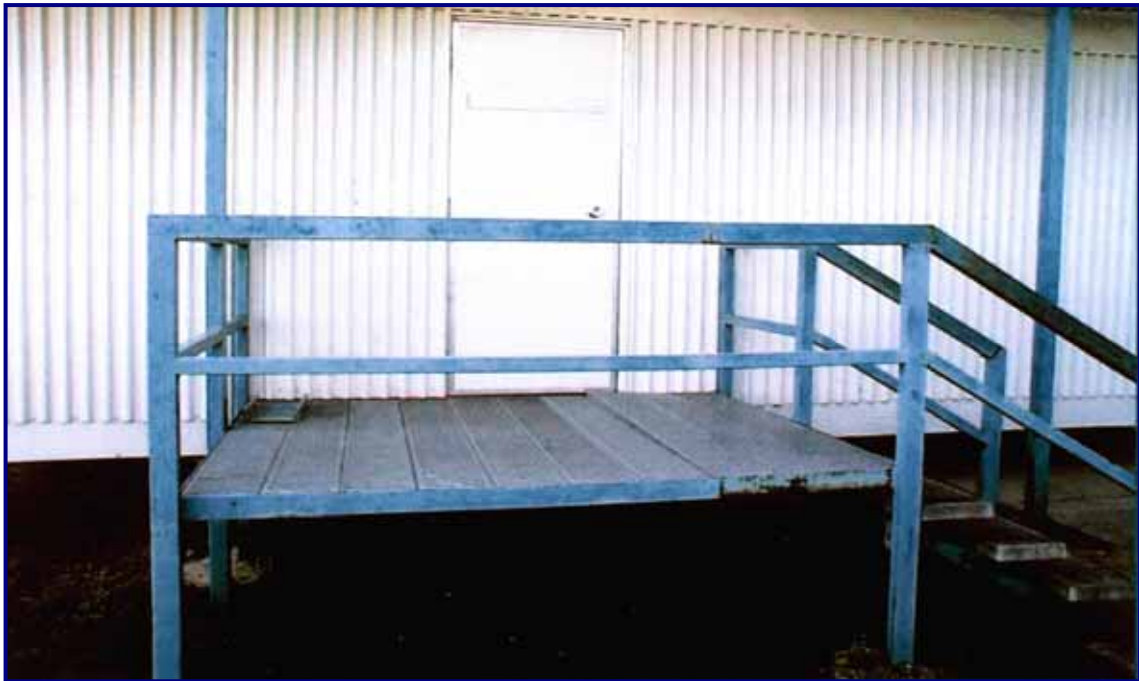
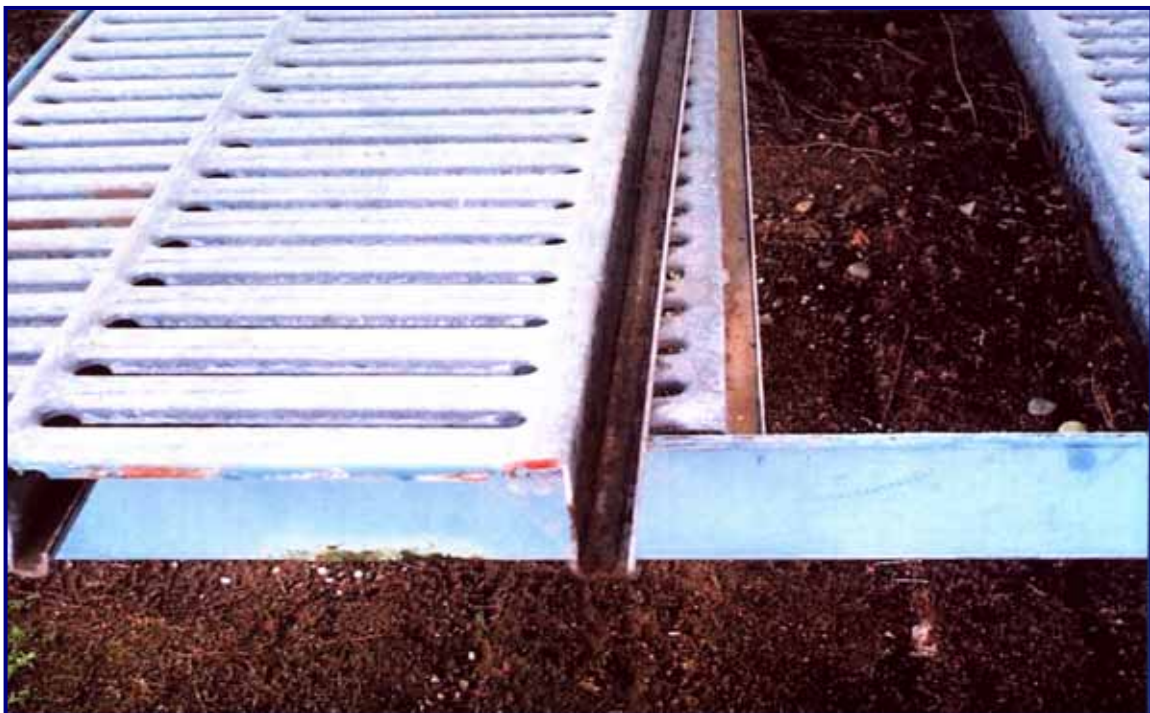
BHP Archerfield

The final area tested was a walkway area at BHP in Archerfield that utilized the Interlok[®] grating system. This walkway was installed in early 1994. This walkway is partially covered by the office it leads into and is entirely covered from the afternoon sun by the main production shed.

All rails sit reasonably flat, which does not allow water to flow out of the down turned lips easily. As can be seen on the following page, there is no evidence of rust in any of the downturn lips, nor do the readings indicate that there is likely to be in the near future. The only sign of rust that can be seen in the photo on the following page is along the edges. This is due to the fact that the product is made from continuously galvanized sheet and when it is cut and rolled to size, it leaves exposed edges.

Obviously by Hot Dip Galvanizing the grating, this problem would be totally eliminated, because all edges are covered with a heavy uniform coating of zinc. Hot Dip Galvanized grating would also provide a zinc coating at least twice as thick as a standard Z450 coating and because the life of a zinc coating is directly proportional to the amount of zinc, this equates to at least twice the life.
