**Performance of Hot Dip Galvanized Coatings**

**East Weipa Mine**

**- Dump Station -**

**CONDUCTED BY: INDUSTRIAL GALVANIZERS**

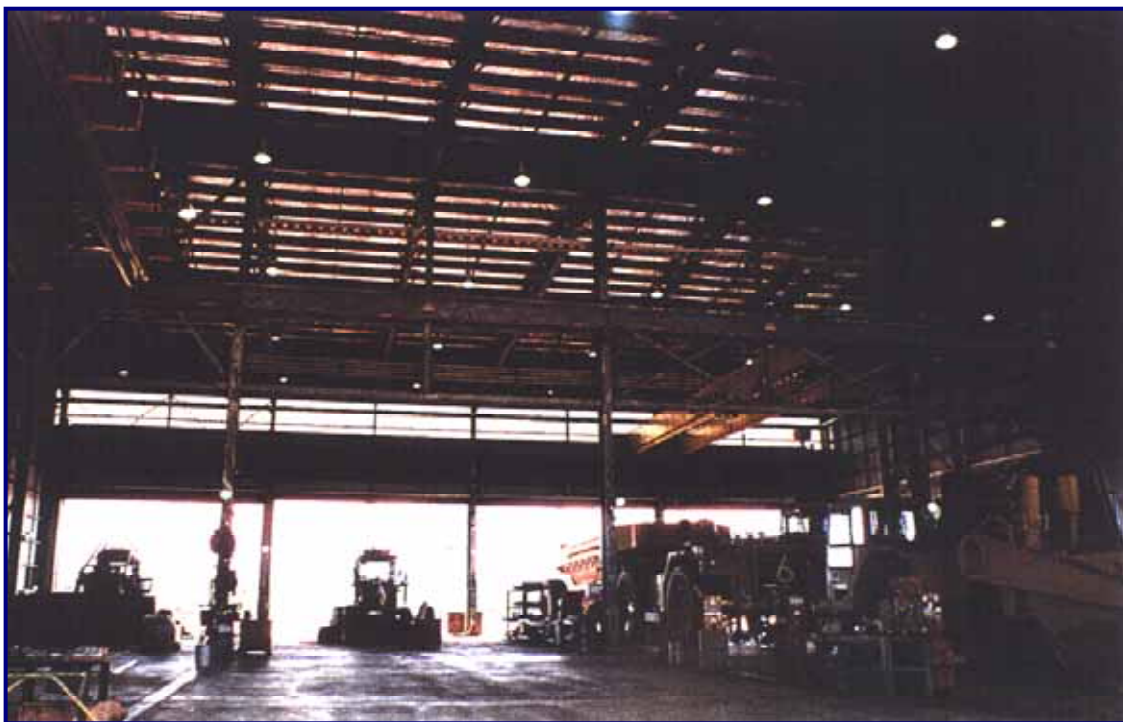
Weipa Dump Station

Duplex Coating – Hot Dip Galvanized with H.B. Epoxy top coat.

Coating thickness ranged from  $250\mu m$  to  $300\mu m$ .
